Pre-CERCLIS Screening Assessment

**Astro Plating Inc.
915 Roosevelt
San Antonio, Bexar County, Texas
TXD044773265**

PRE-CERCLIS SCREENING ASSESSMENT

Astro Plating Inc.
915 Roosevelt
San Antonio, Bexar County, Texas

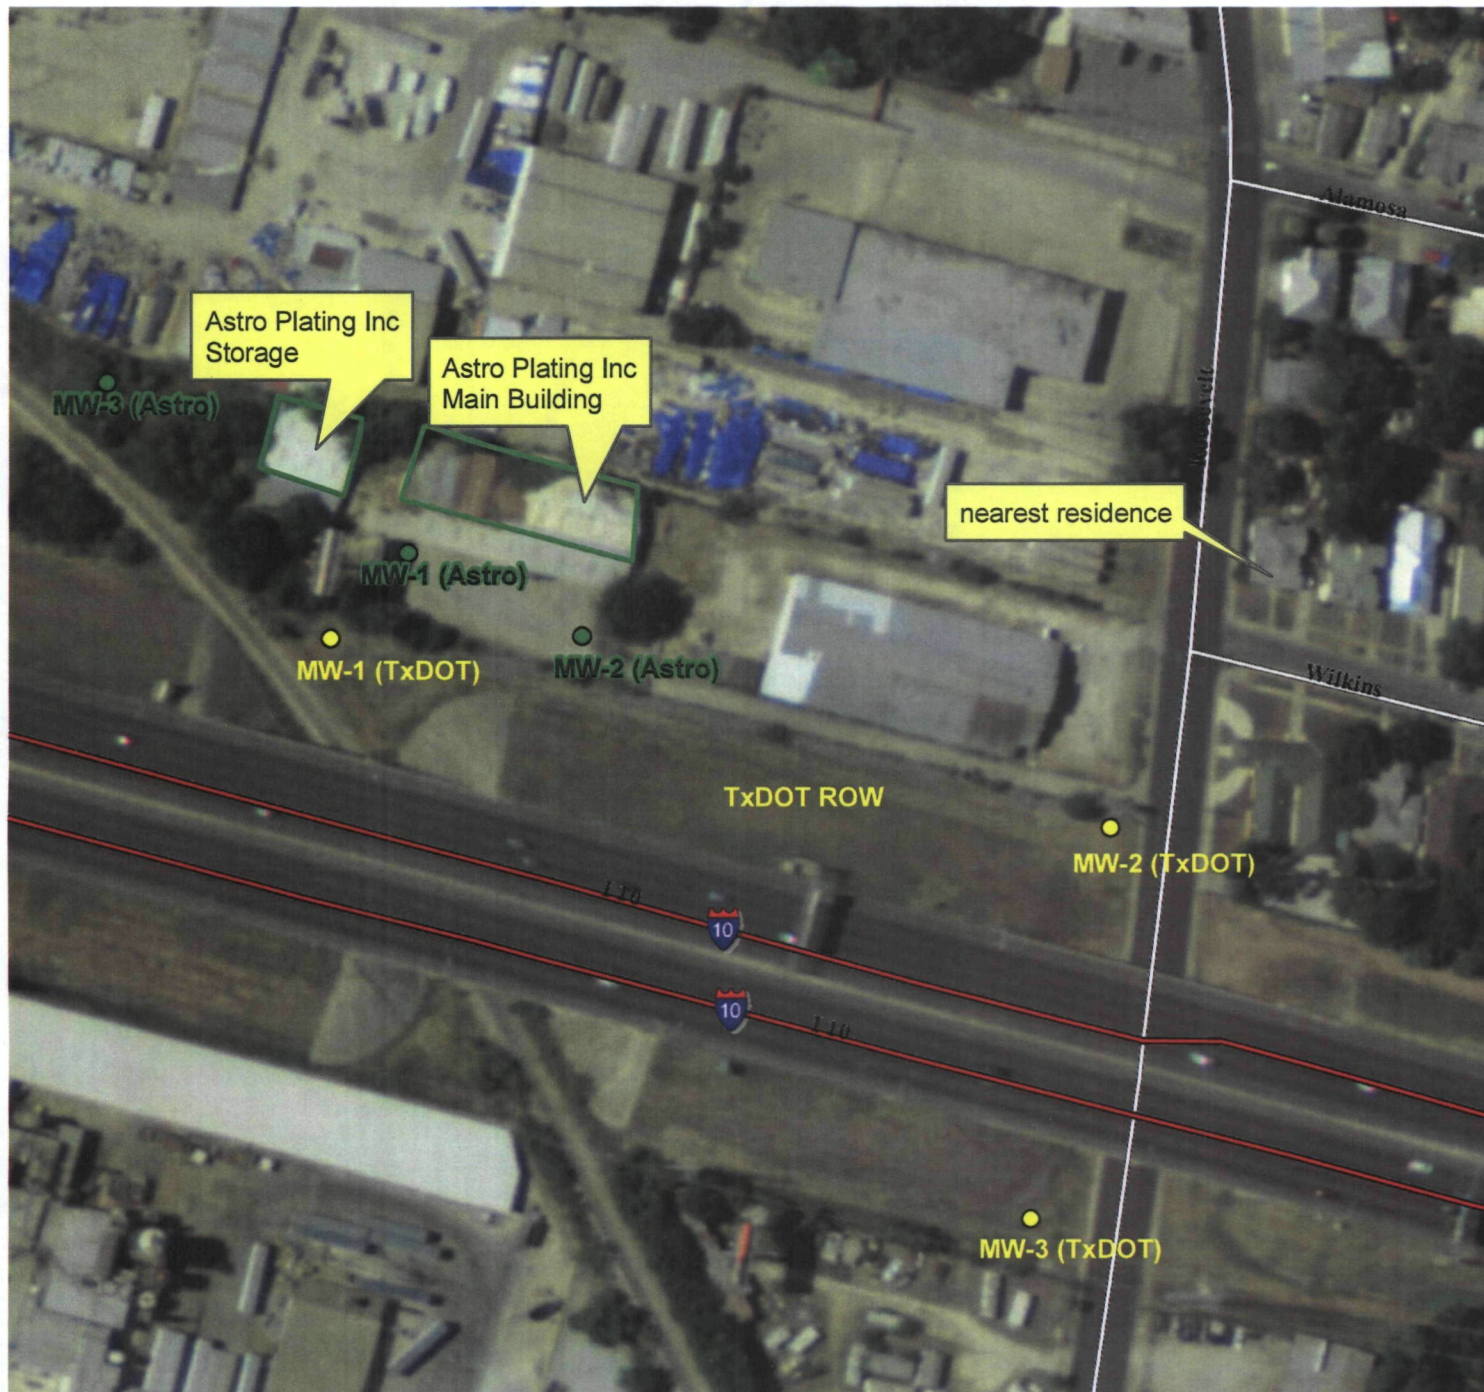
Site Features Map

Note: Monitoring well locations are approximate.

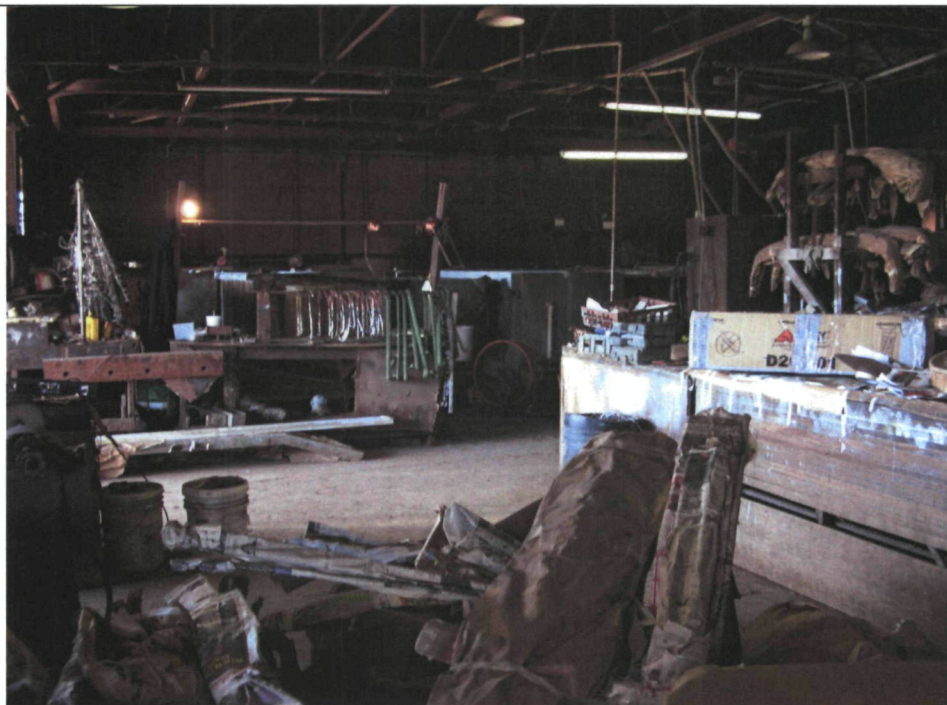
Photograph: 1

Description: Inside the main building of Astro Plating, looking in the direction of the Storage/Racking area and Electroplating area with acid rinse tanks.

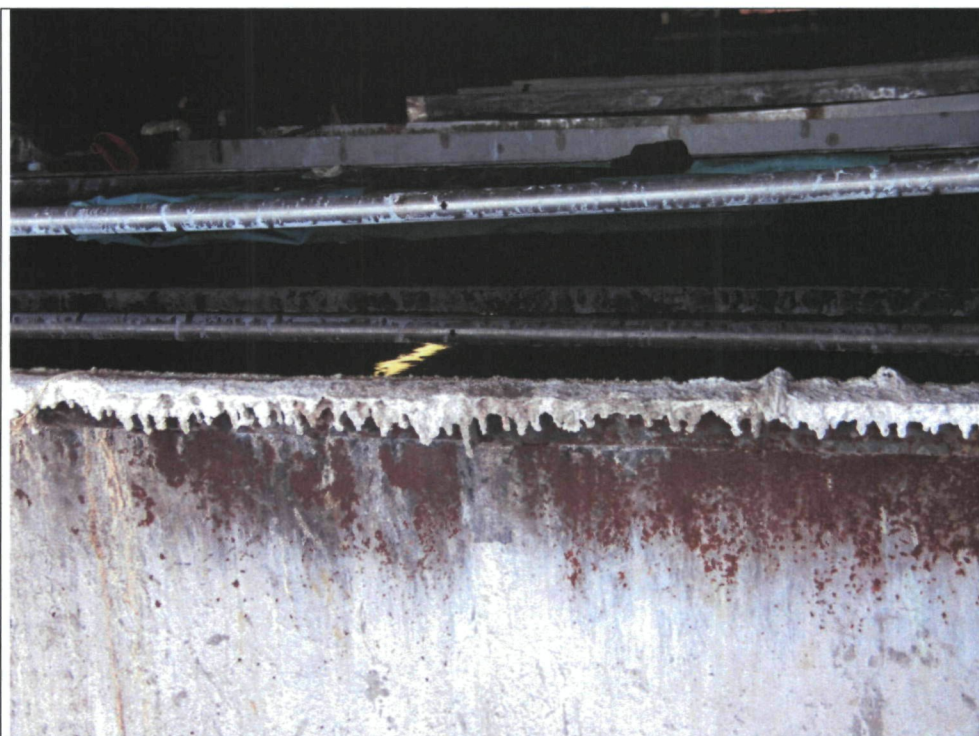
Photograph: 2

Description: Side of caustic dip tank. Notice precipitate on rim.

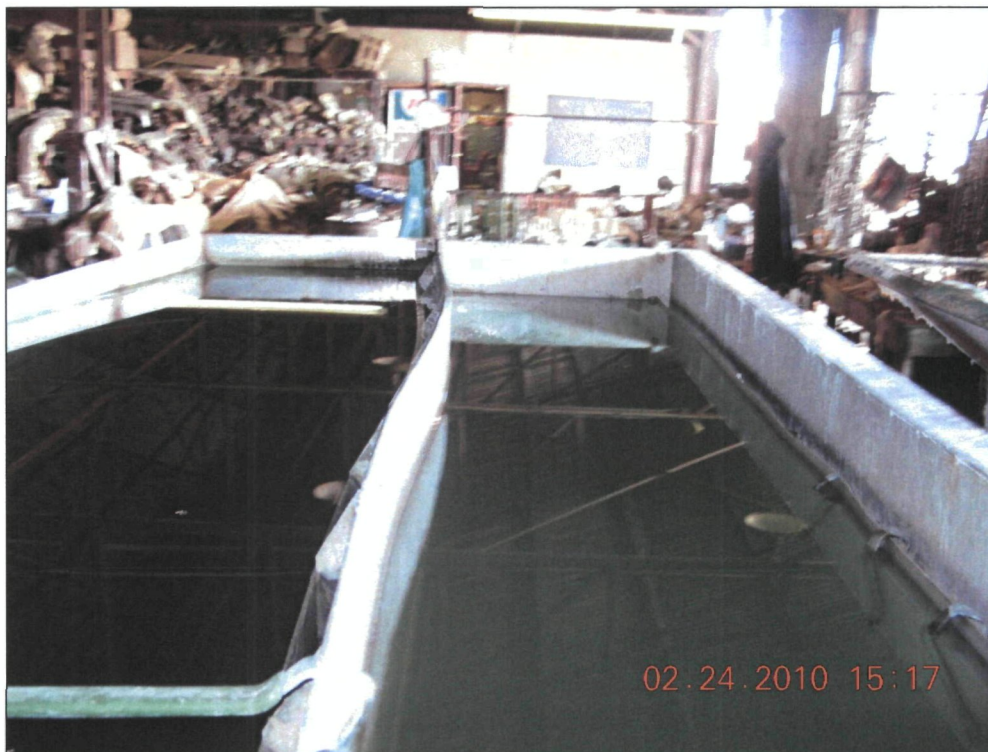
Photograph: 3	Date: 2/24/2010
Photographer: Susy Loftus	Direction: East
Description: Acid waste rinse tank.

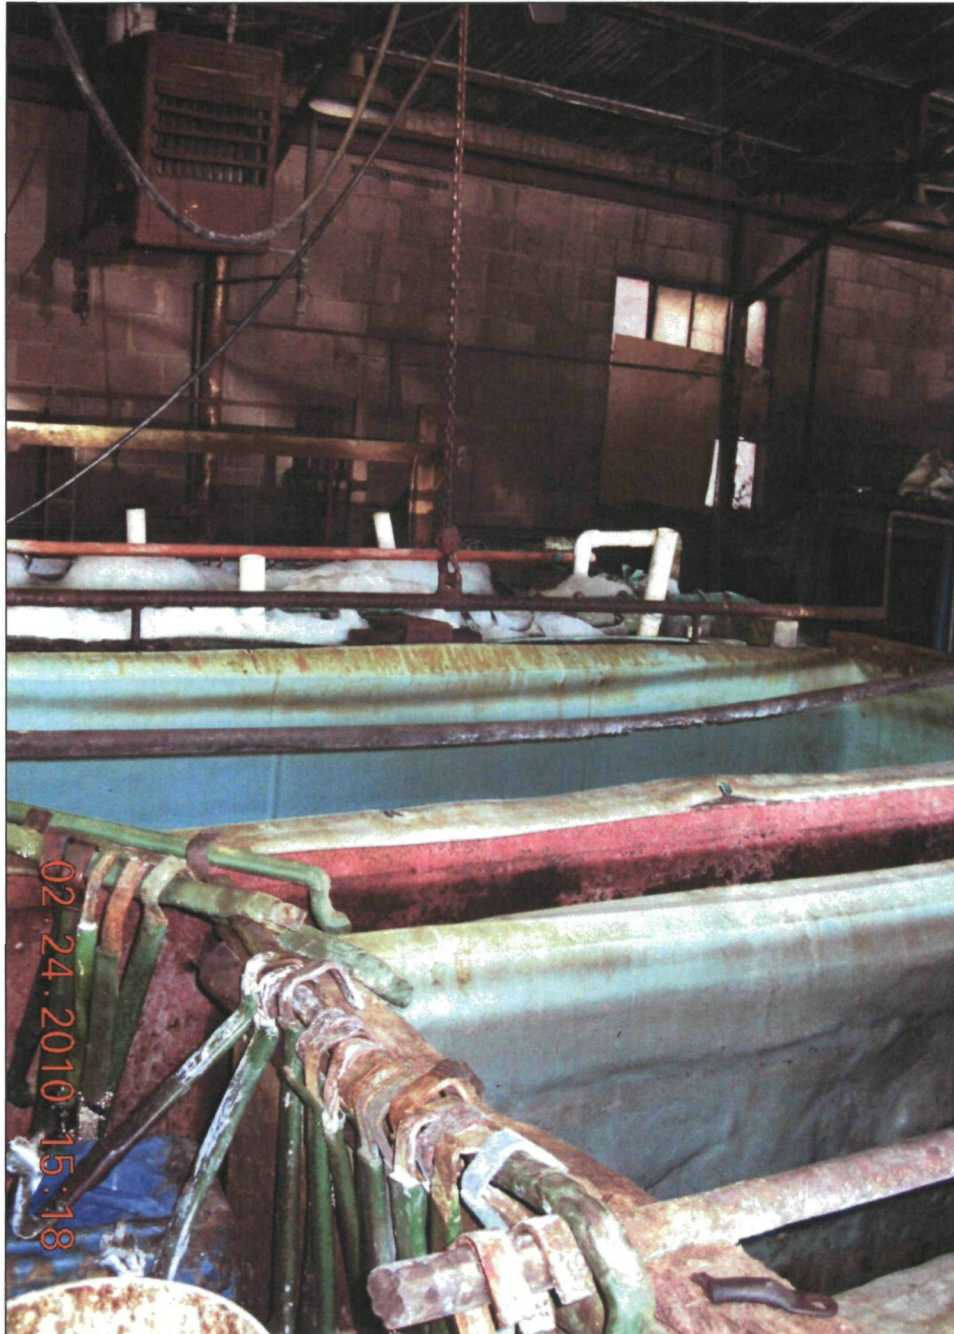
Photograph: 5

Description: Zinc bath, Zinc rinse tank, and boiling Nickel bath in back.

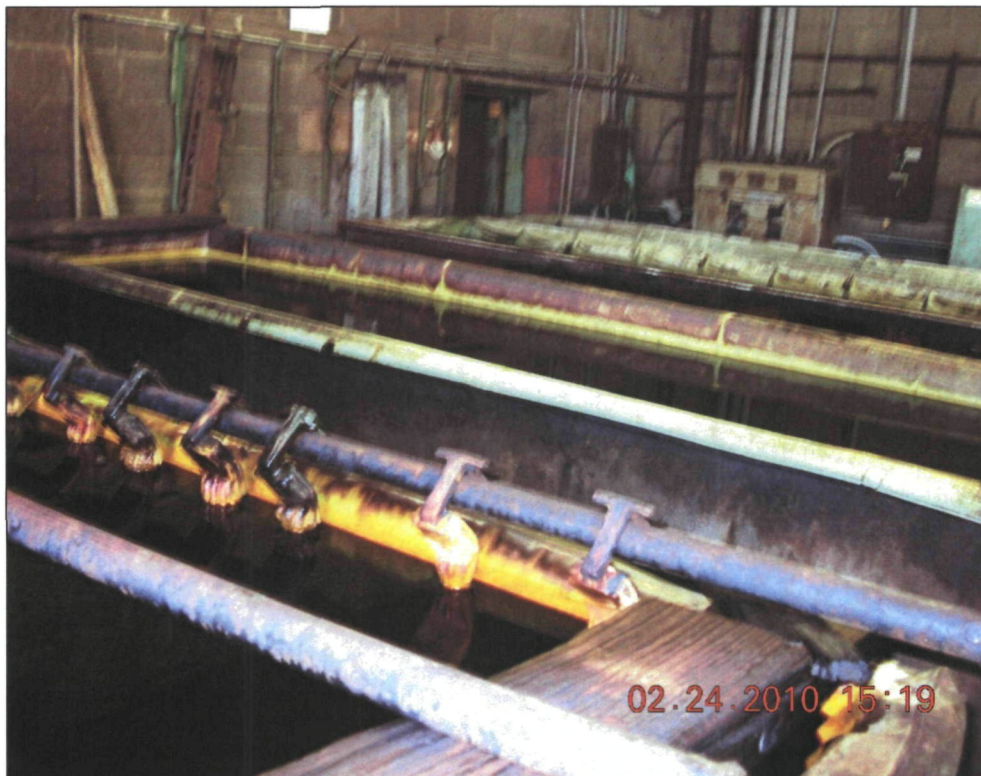
Photograph: 6	Date: 2/24/2010
Photographer: Susy Loftus	Direction: Northwest
Description: Chromium baths and Nickel rinse tank

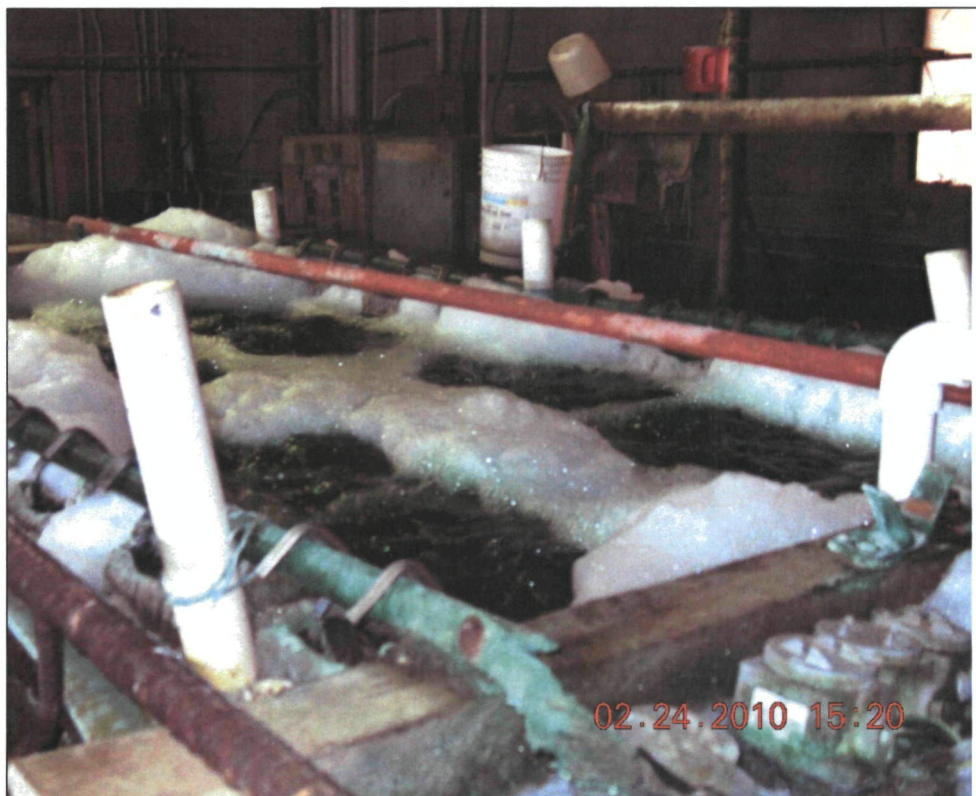
Photograph: 7	Date: 2/24/2010
Photographer: Susy Loftus	Direction: Northwest
Description: Boiling Nickel bath

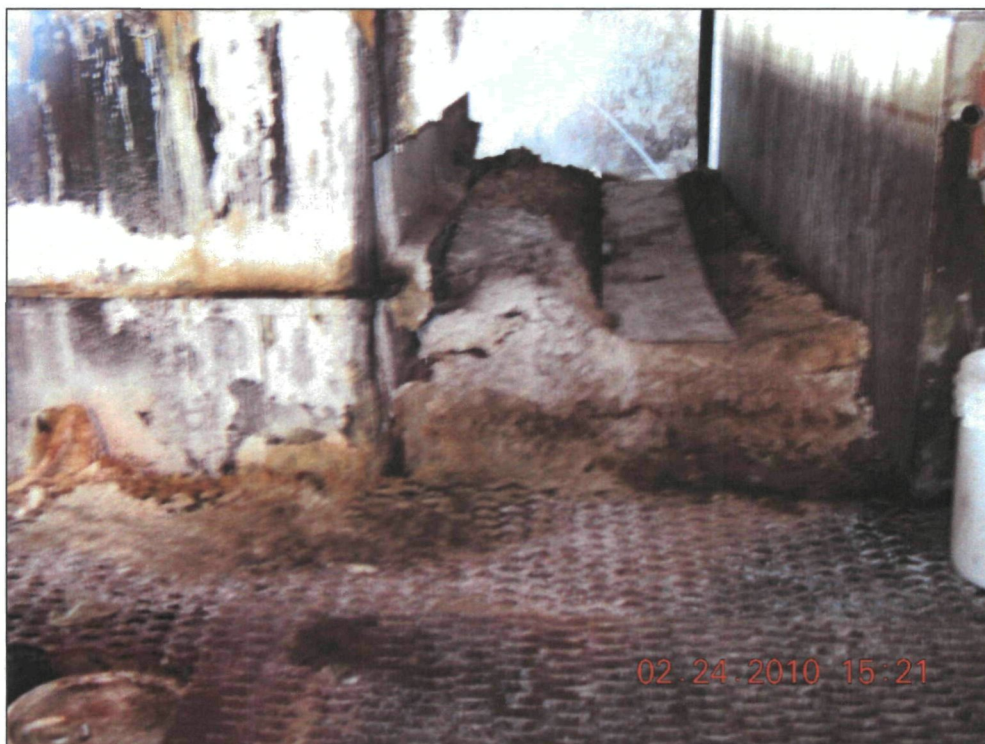
Photograph: 8	Date: 2/24/2010
Photographer: Susy Loftus	Direction: West
Description: Grating underneath acid/rinse tanks.

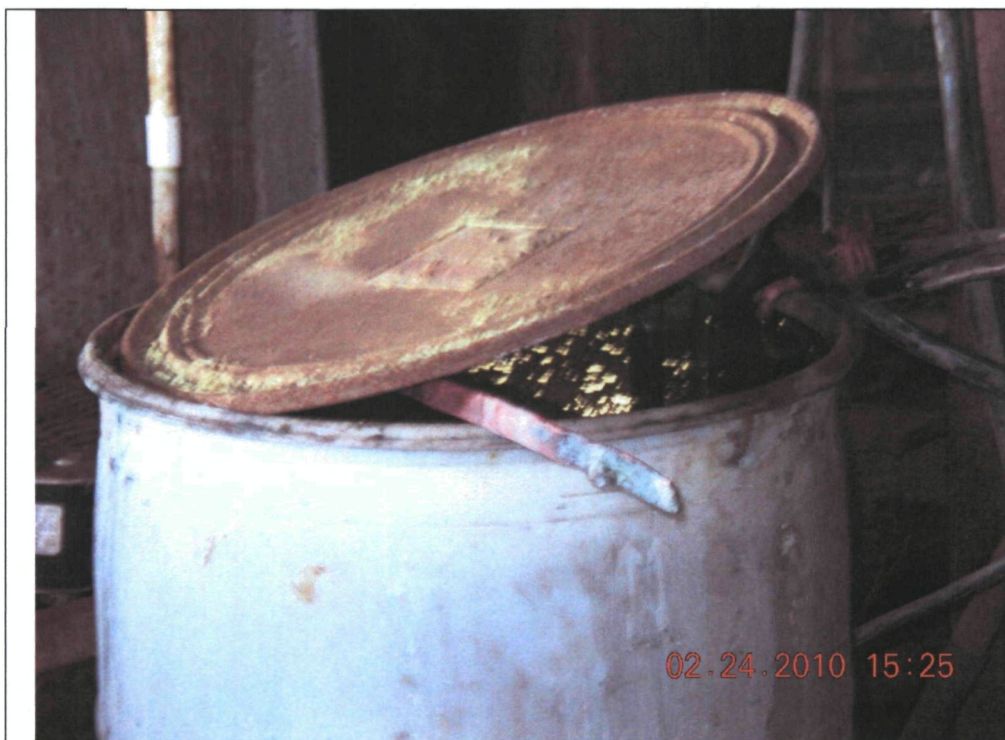
Photograph: 9	Date: 2/24/2010
Photographer: Susy Loftus	Direction: North
Description: Drum of gold rinse.

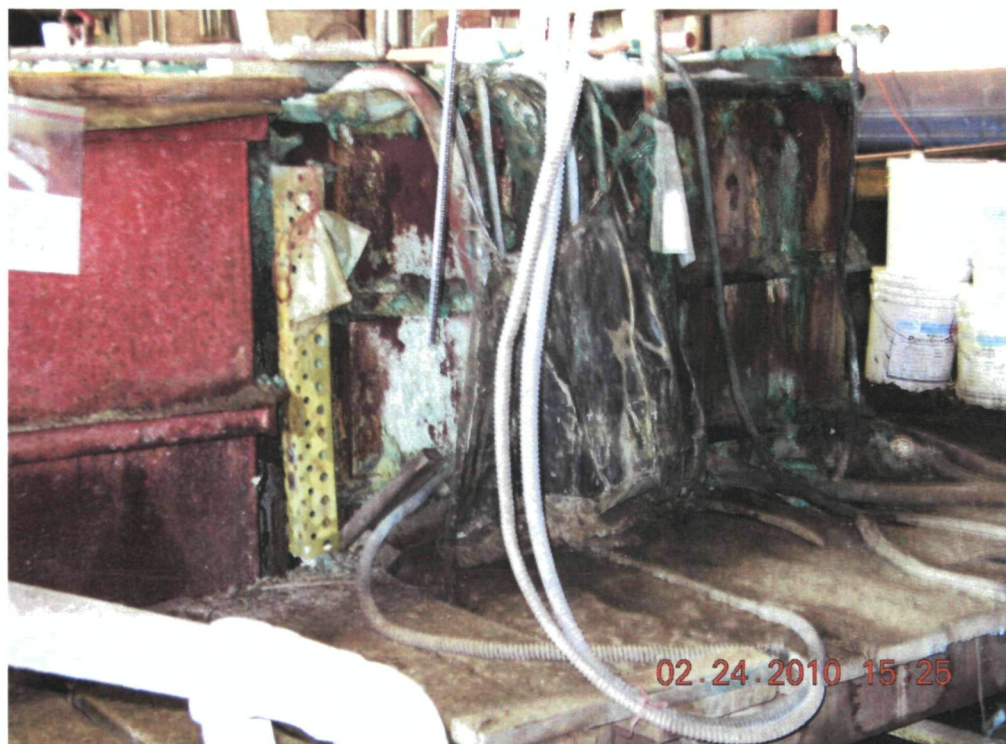
Photograph: 10	Date: 2/24/2010
Photographer: Susy Loftus	Direction: West
Description: Sides of some of the metal rinse tanks.

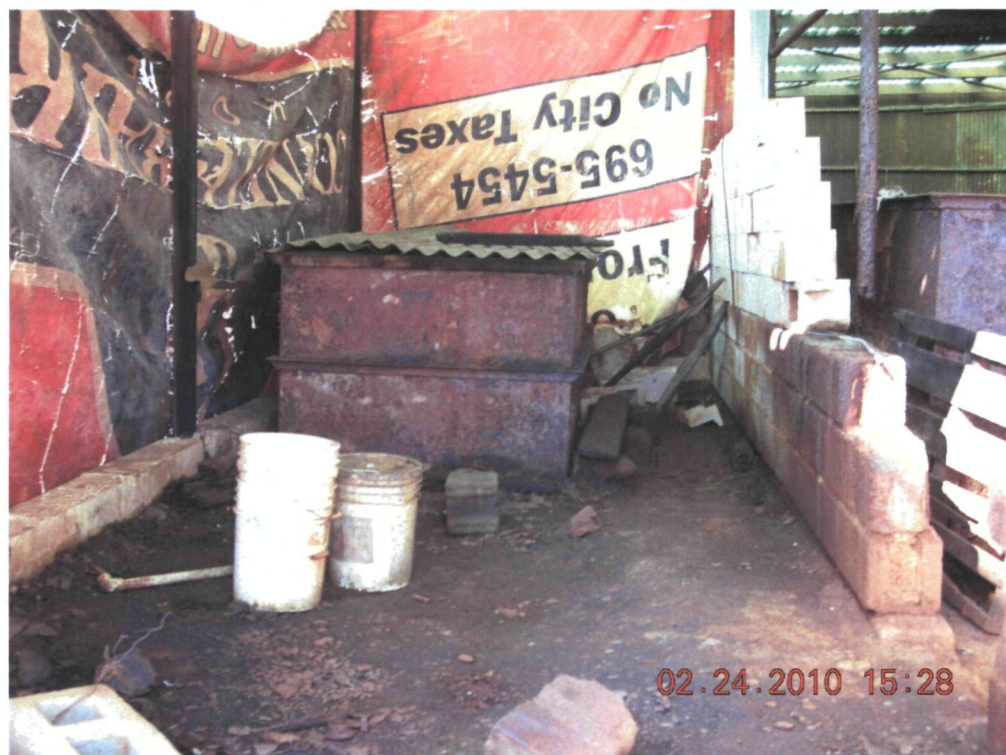
Photograph: 11	Date: 2/24/2010
Photographer: Susy Loftus	Direction: North
Description: Muriatic acid tank in Metal/Paint Stripping area. Note staining on concrete bricks.

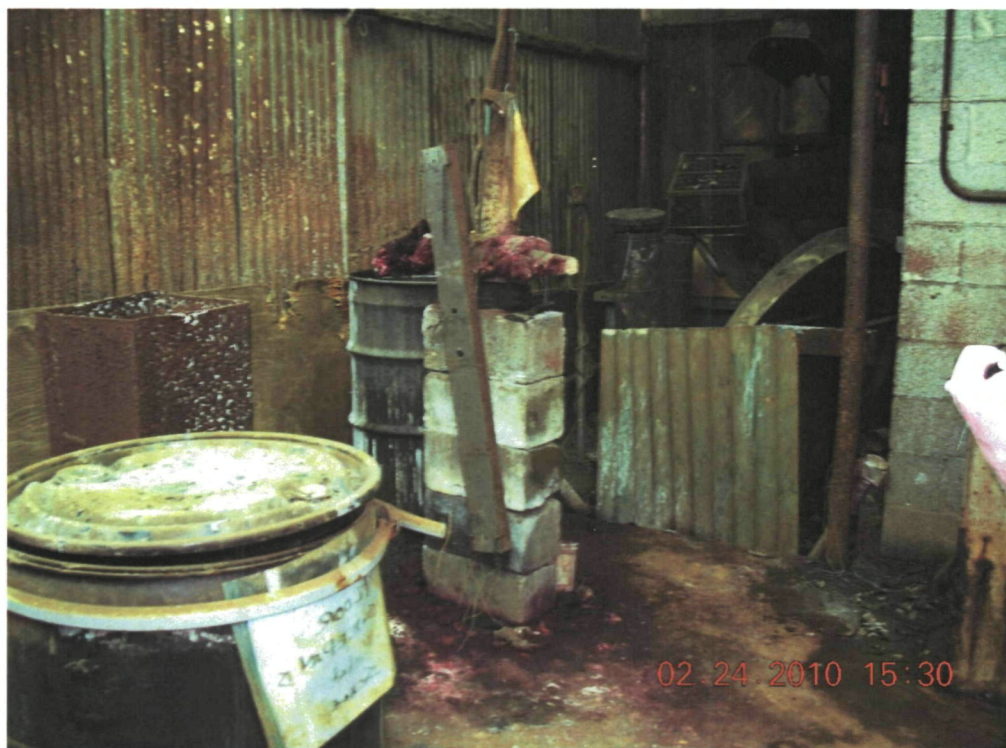
Photograph: 12	Date: 2/24/2010
Photographer: Susy Loftus	Direction: Northeast
Description: Caustic soda rinse drum in Metal/Paint Stripping area. Note staining on floor.

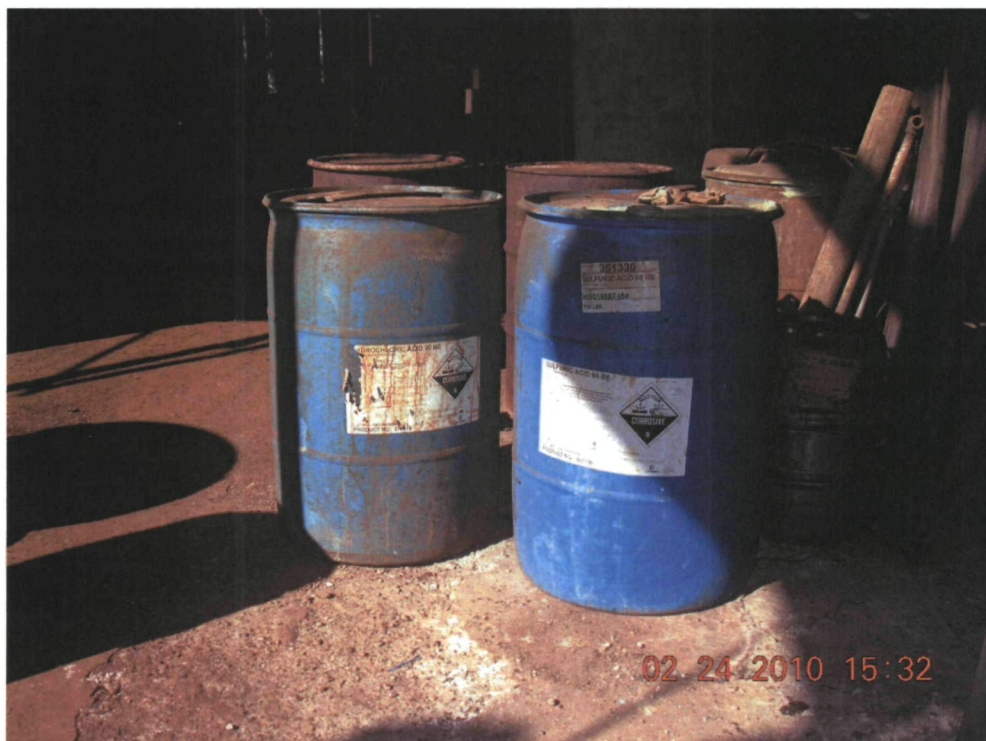
Photograph: 13	Date: 2/24/2010
Photographer: Susy Loftus	Direction: North
Description: Drums of Sulfuric acid and Hydrochloric acid.

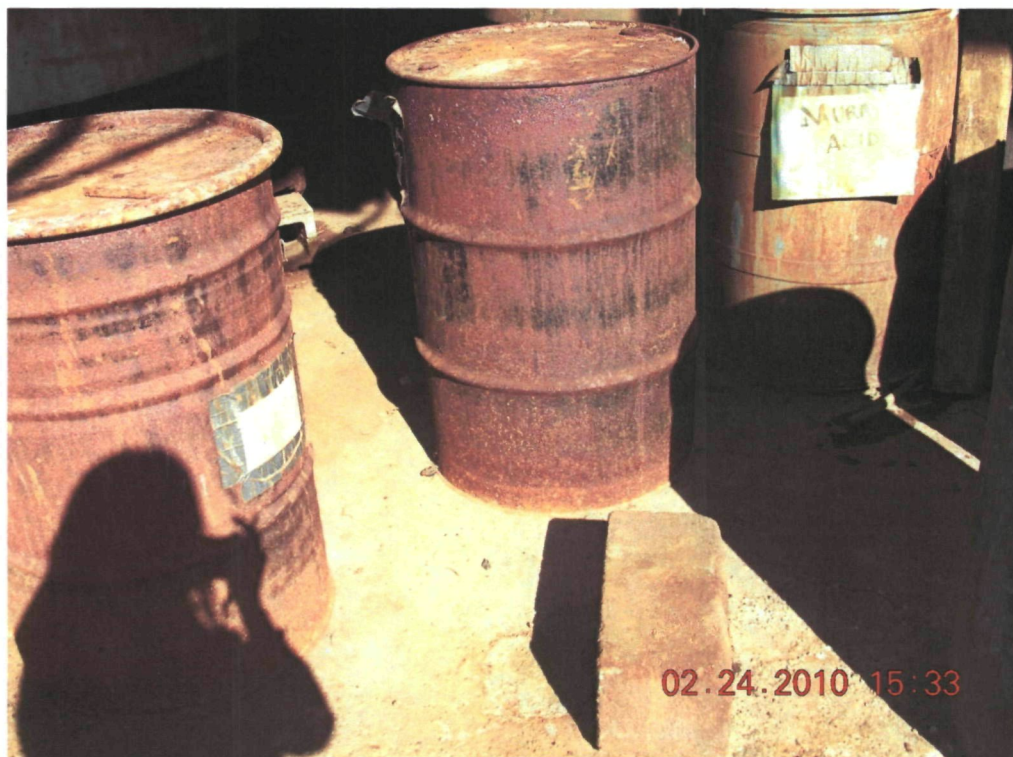
Photograph: 14	Date: 2/24/2010
Photographer: Susy Loftus	Direction: North
Description: Rusted drums of Muriatic acid and waste water.

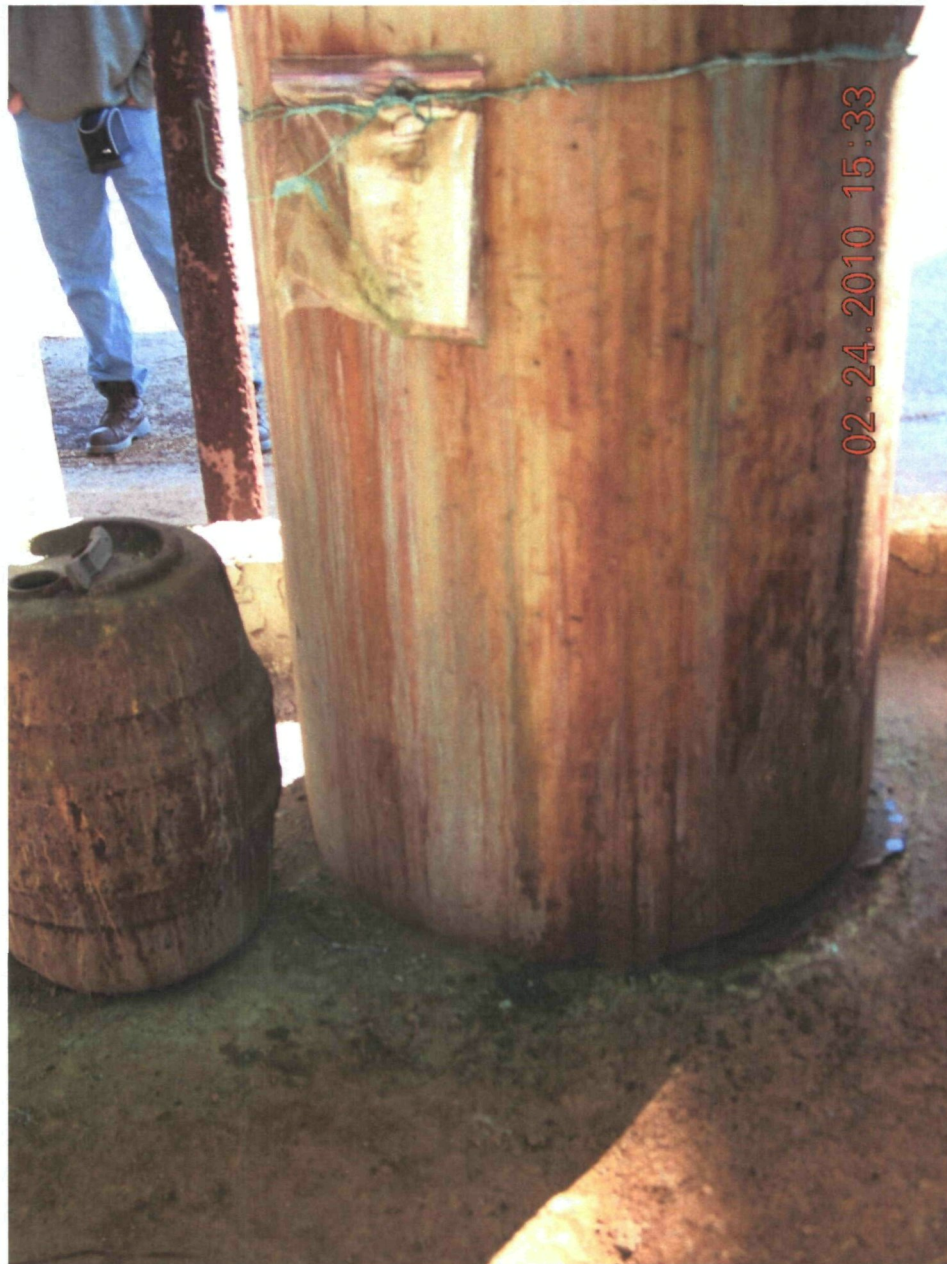
Photograph: 15	Date: 2/24/2010
Photographer: Susy Loftus	Direction: South
Description: Drums of Nitric acid. Notice staining on outside of drum.

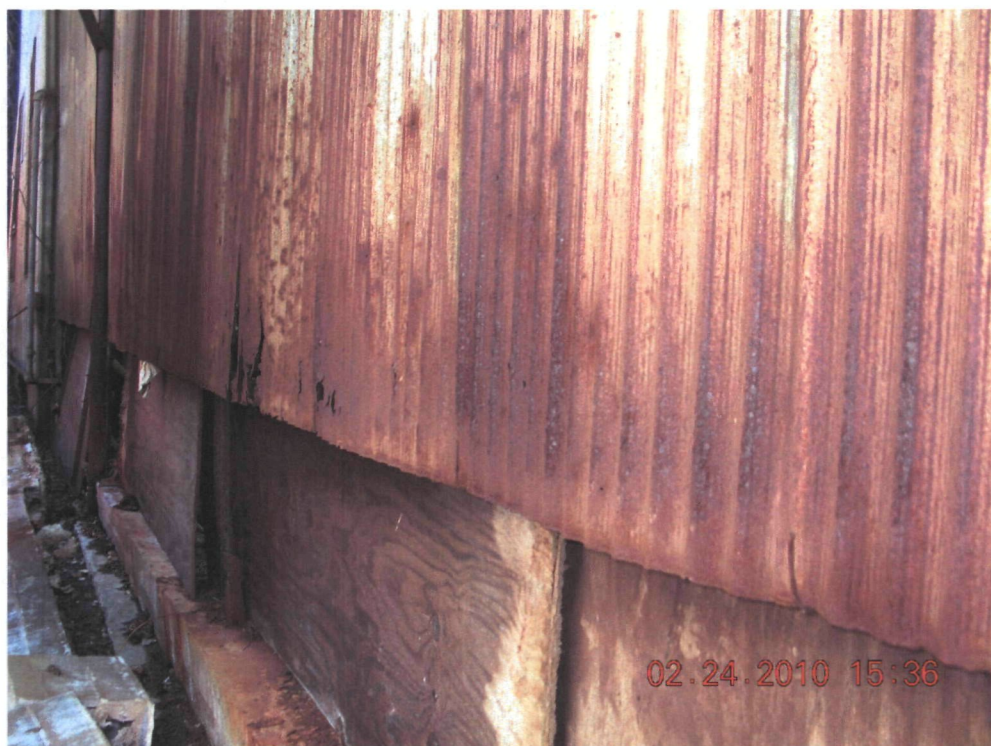
Photograph: 17

Description: Rusty outside wall of main building.

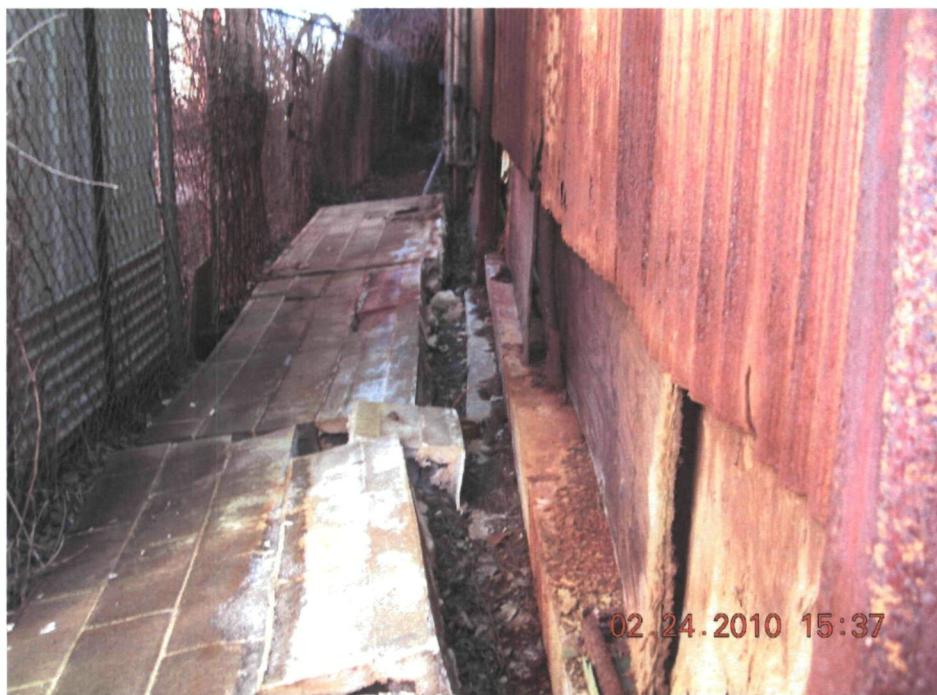
Potential sources for hazardous substances associated with the Site include rusty drums and potentially leaky tanks of caustic acid and nickel, chromium, zinc, and copper rinse. There are approximately 10 rusty 55-gallon and smaller drums (Appendix D Photographs 13 and 14; Appendix E, p. 3) and approximately 15 bath/rinse tanks (Appendix D Photographs 2-7). The tanks are located in the Electroplating Area with additional drums located in the Metal/Paint Stripping Area. The outside western wall and the back northern wall of the Metal/Paint Stripping Area are rusty and have some orange and pink staining (Appendix D Photographs 16-19). A short concrete brick wall that stood on the northern outside perimeter of the building has collapsed (Appendix D Photograph 18)

Photograph: 18	Date: 2/24/2010
Photographer: Susy Loftus	Direction: East
Description: Rusty wall of main building, fallen concrete brick wall, property line fence. Note staining on fallen bricks.

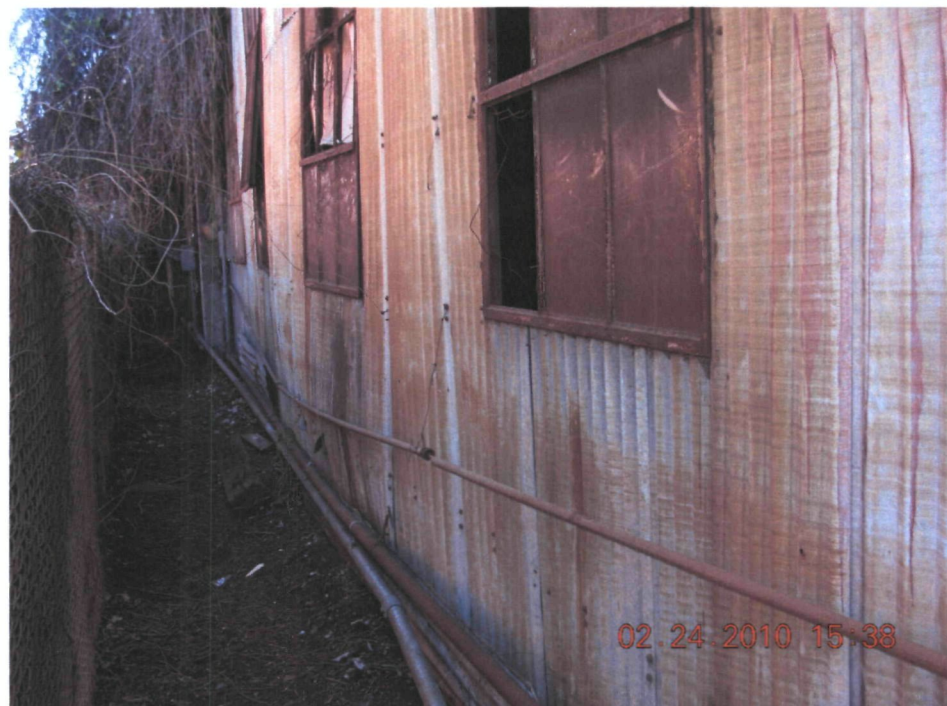
Photograph: 19	Date: 2/24/2010
Photographer: Susy Loftus	Direction: East
Description: Behind main building

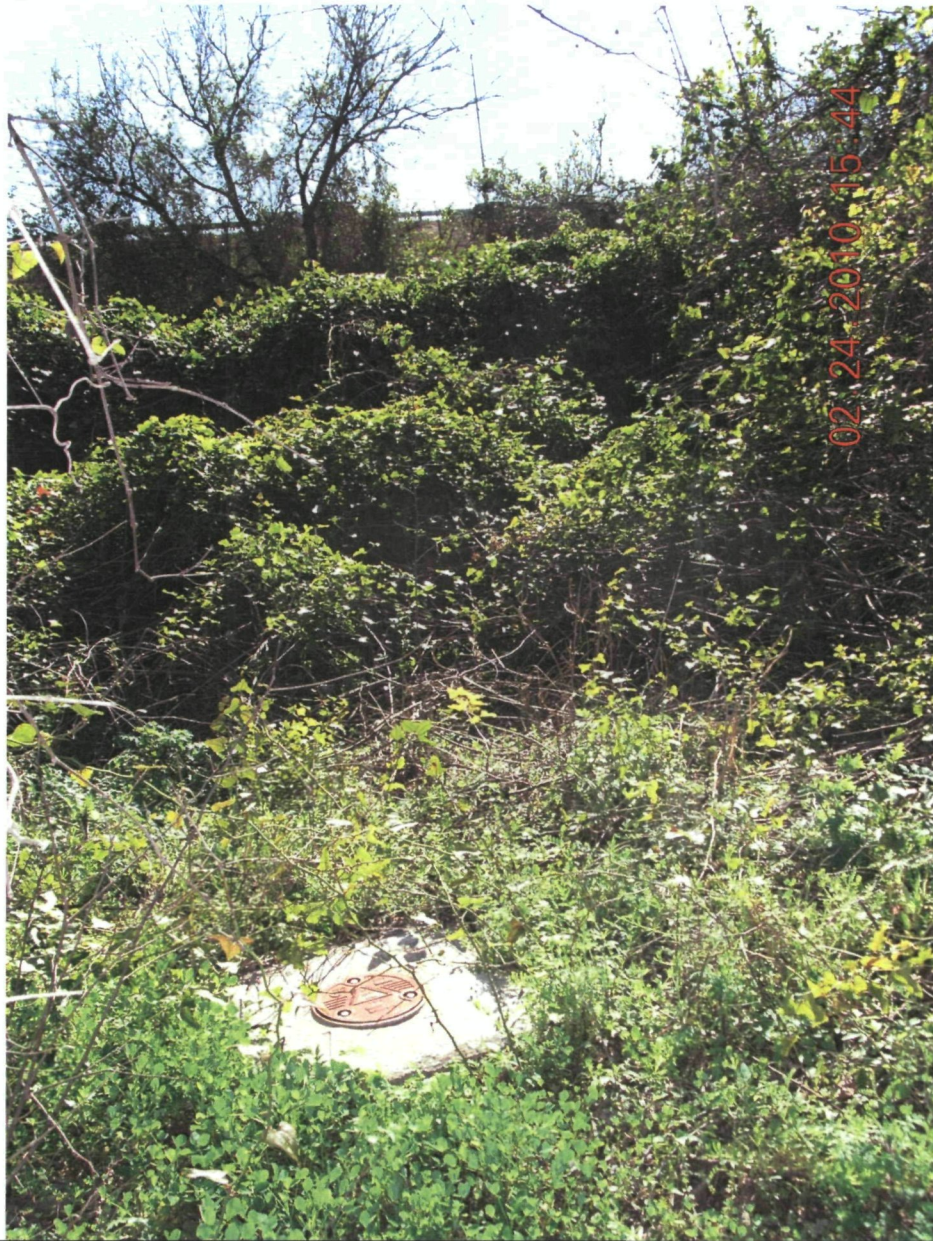
Photograph: 20	Date: 2/24/2010
Photographer: Susy Loftus	Direction: South
Description: Monitor well installed on property.
